Inspection and Cleaning of Flexible Riser Annulus Vent Ports

Gilles Gardner and Adam Armstrong

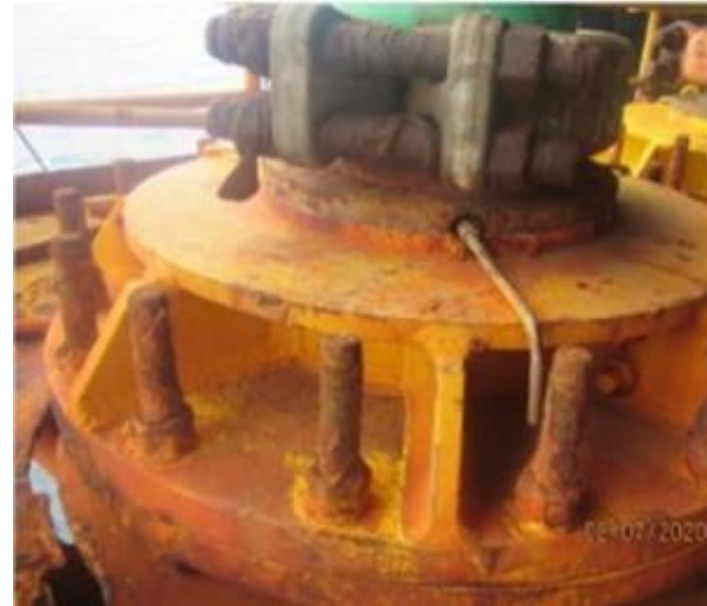
- Free Venting
- Lack of Vent Valves
- Inspection of Vent Port Tubing
- Poor Vent Flow
- Potential Blockages

Configuration of
Venting
Arrangement

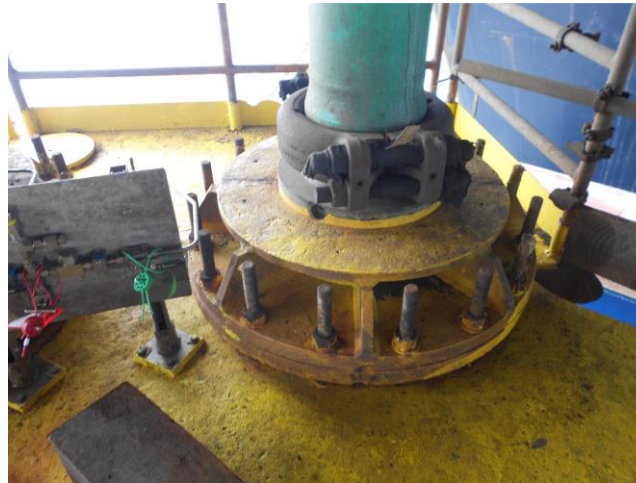
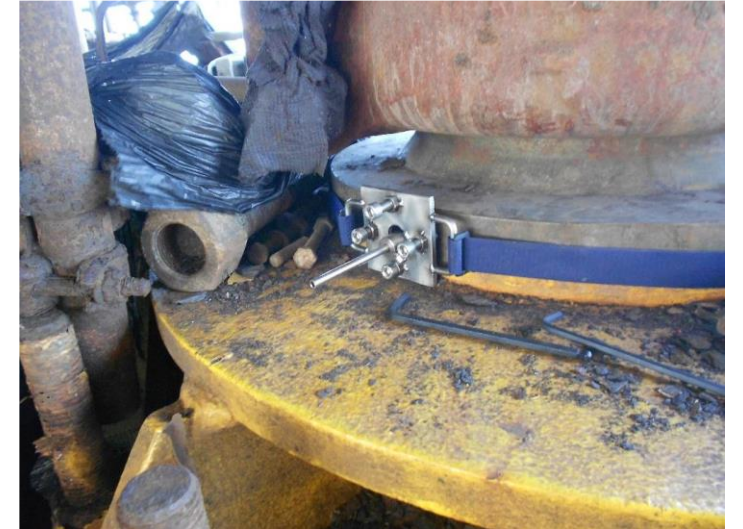
- Access Created Limitations
- Alignment Spacer Dimensions Clashed with Collar
- Simplified Setup
- Alignment Fixture Aligned with Flange
- Each Hangoff Position Was Different

Be Prepared to
Make Changes

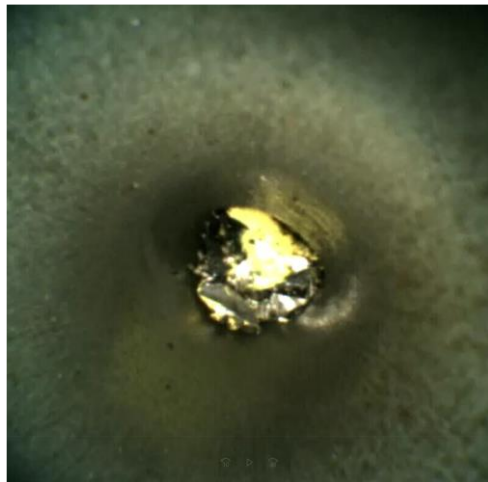
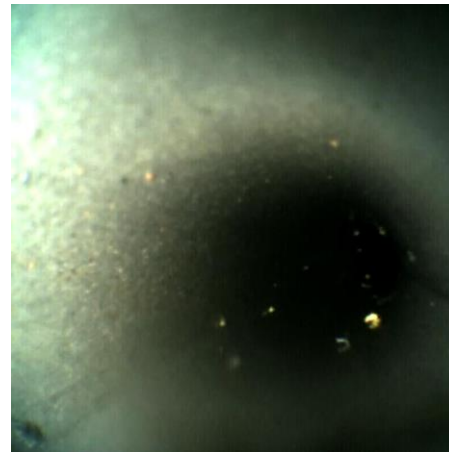
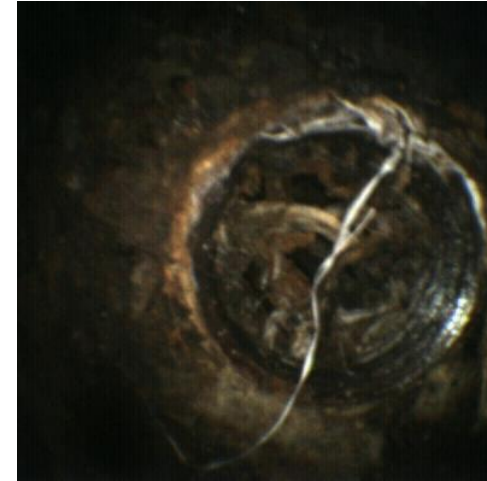
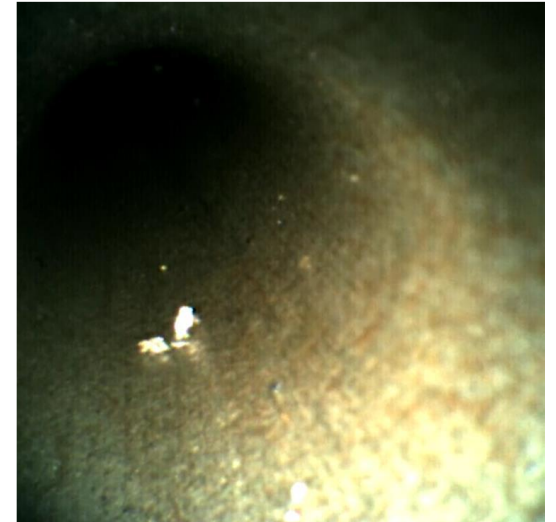
- Excellent Images
- Assess Condition of Vent Port Tubing
- Access Issues
- Burring and Debris

Tubing Condition

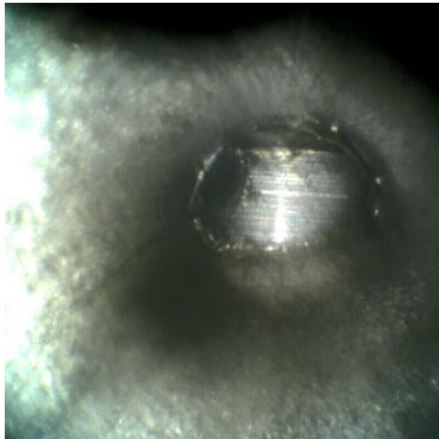
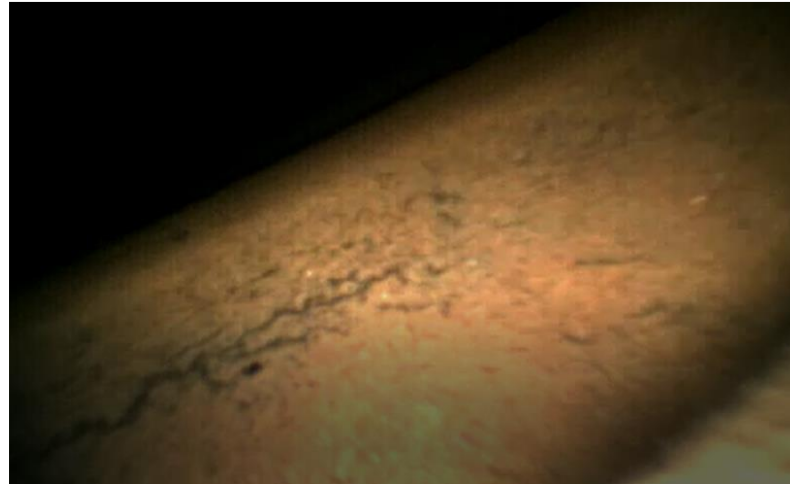
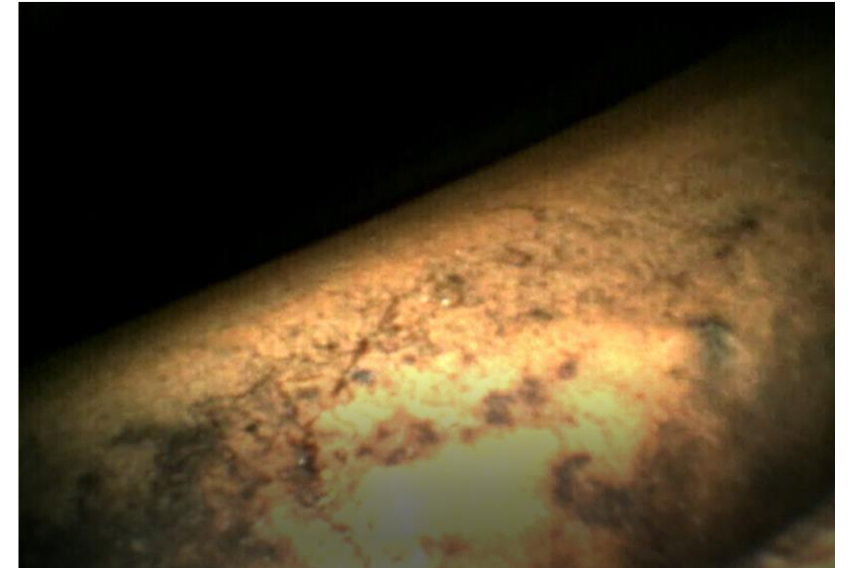
- Some Signs of Degradation
- Oxidation
- Cracking
- Discolouration

Structural
Component
Condition

- Inspection Tool Performed Well
- Images Provide Valuable Insight
- Medium Levels of Corrosion Found
- Carcass Oxidisation, Cracking and Discolouration
- Vent Tubing – Superficial Corrosion
- Corrosion Caused by High Moisture/Oxygen Levels in Annulus

- Poorly Vented Risers – Annulus Open to Environment
- Vent Valve or One-Way Valve Critical (API 17B Recommended)
