Inspection and Cleaning of Flexible Riser Annulus Vent Ports

Gilles Gardner and Adam Armstrong

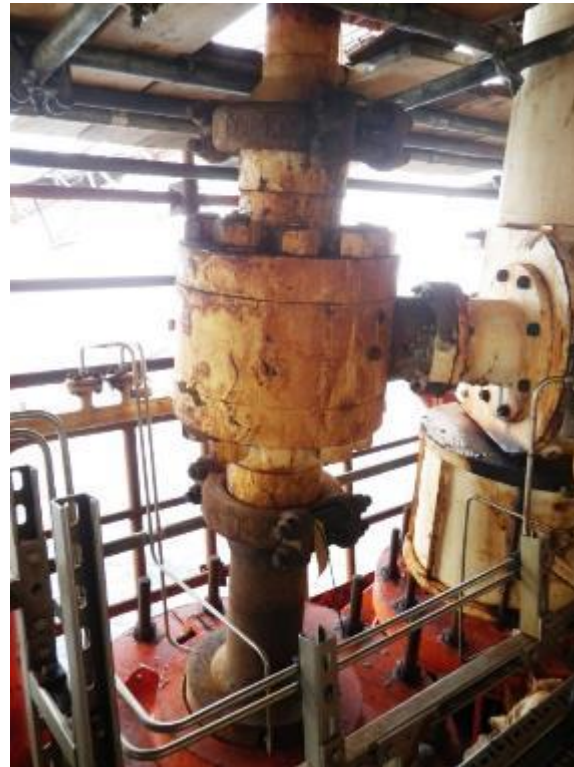
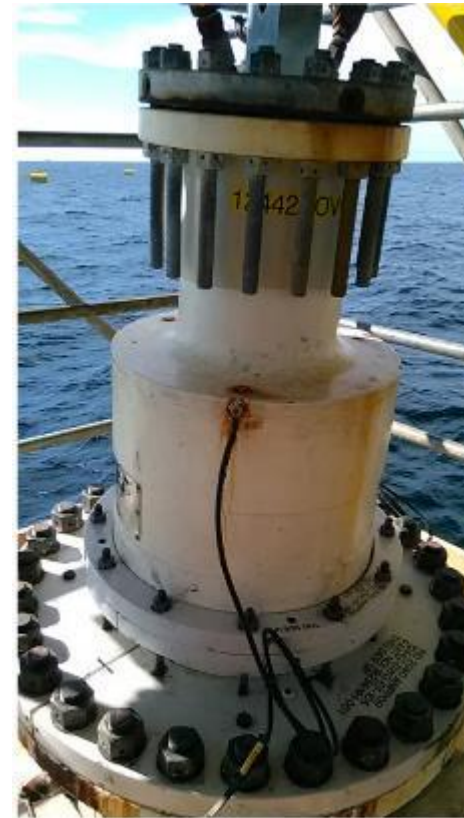
Annulus Vent Ports Can Become Fouled

- Condensation and Precipitates
- Manufacturing Debris
- Filled Vent Ports
- Poor Vent Port Design
- Prevent Backflow of Liquids
- Prevent Backflow of Corrosive Gases

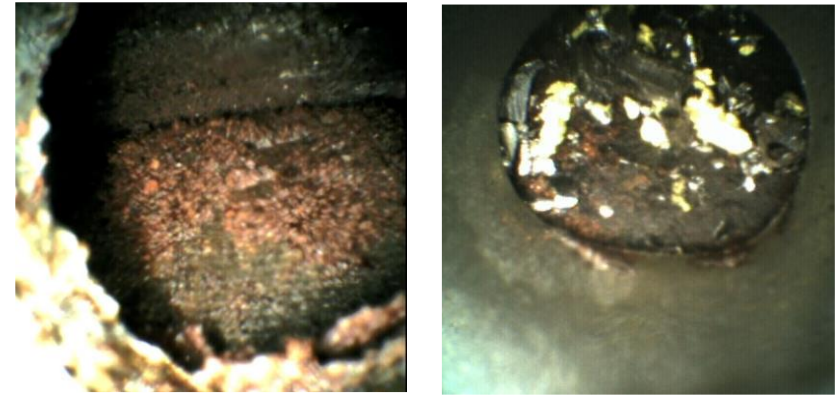
- Inspect the Venting Arrangement for Blockages
- Clean Precipitates
- Is Corrosion Present?
- Visually inspect on a regular basis to assess accelerated corrosion
- Understand Type of Corrosion
- Check for Structural Damage e.g. Broken Wires

Visual inspection of
critical components

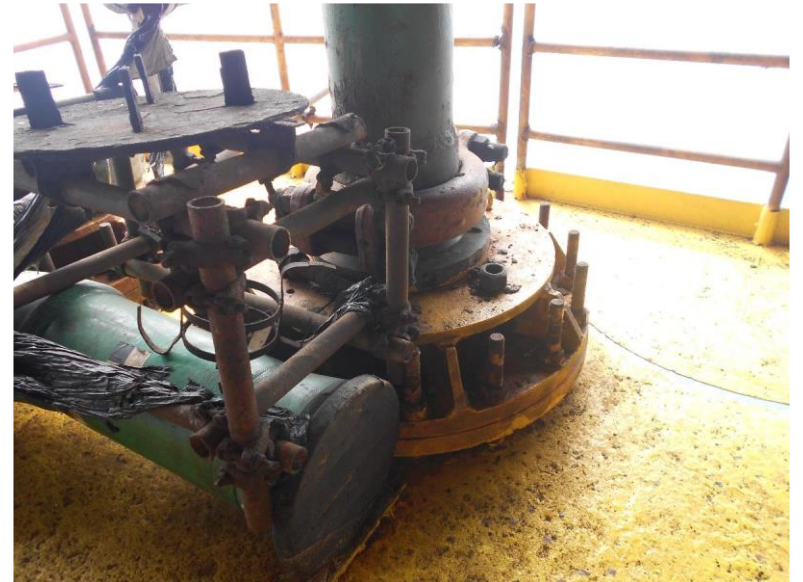
- Inspection Tool Performed Well
- Images Provide Valuable Insight
- Medium Levels of Corrosion Found
- Carcass Oxidisation, Cracking and Discolouration
- Vent Tubing – Superficial Corrosion
- Corrosion Caused by High Moisture/Oxygen Levels in Annulus

Good Practice to
Isolate Annulus
with Valve

- Poorly Vented Risers – Annulus Open to Environment
- Vent Valve or One-Way Valve Critical (API 17B Recommended)
