# Sureflex JIP - Industry Guidance and Good Practice for Unbonded Flexible Pipe Systems

Subsea Expo '24

# The Sureflex JIP

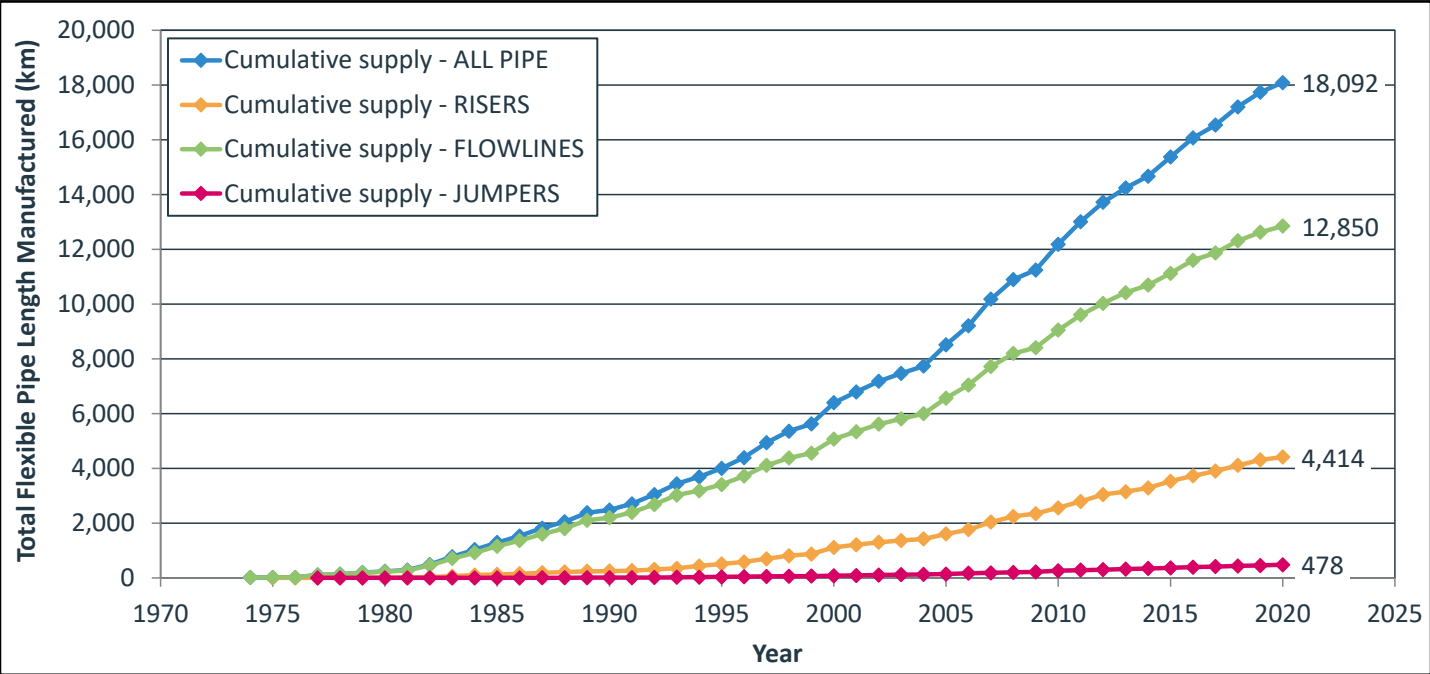
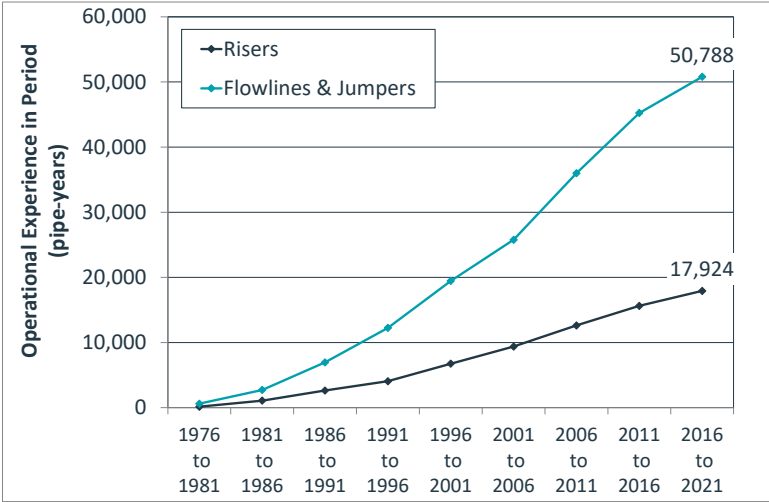
# Flexible Pipe Population

The Sureflex membership includes the three main manufactures allowing the JIP to compile the most comprehensive dataset relating to the global population supply of unbonded flexible pipes.

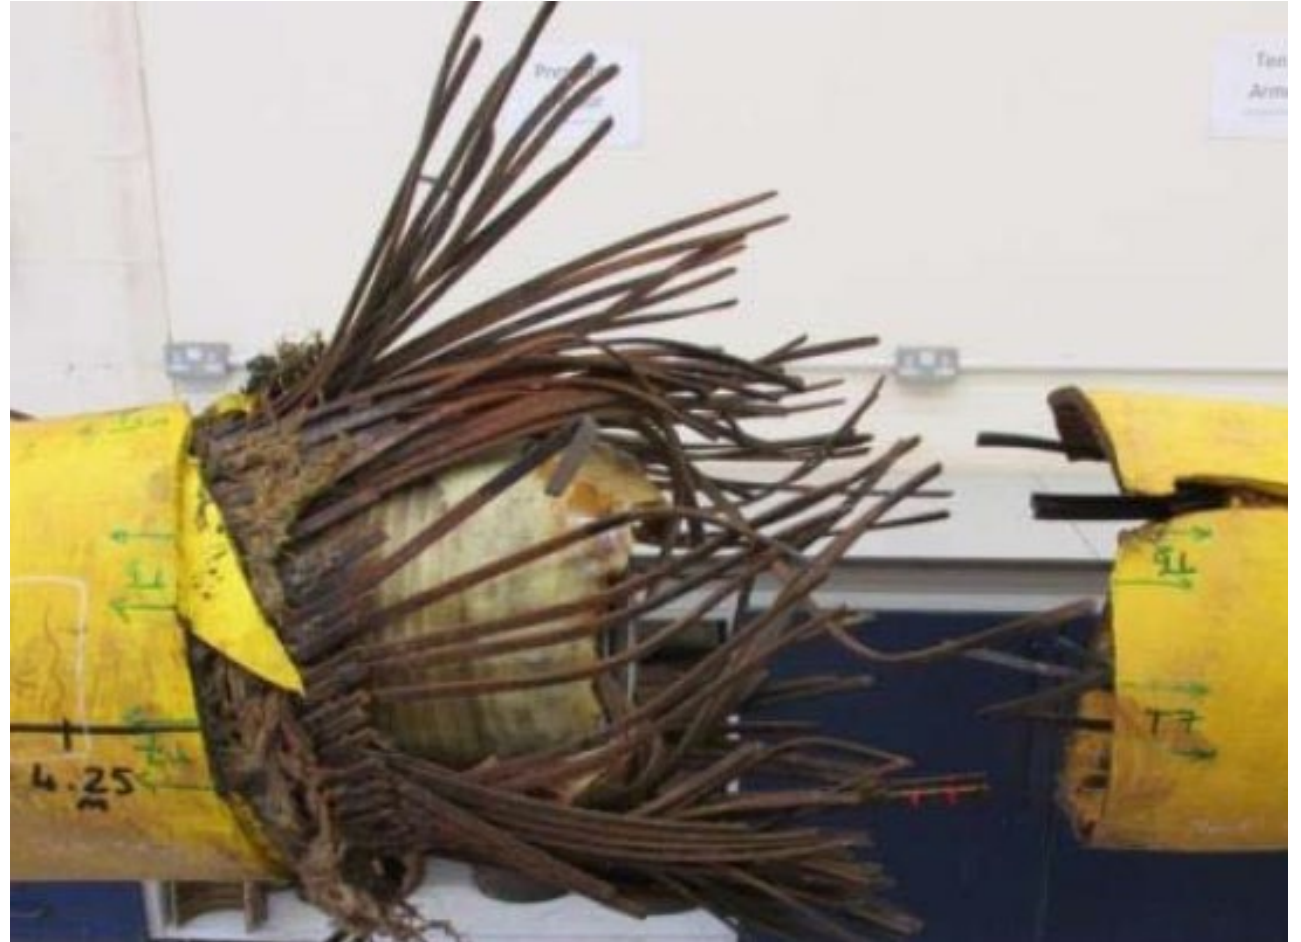
# Key Emergent Threats

Key emergent failure modes that have been shared with the industry during the most recent revision of the JIP:

- Stress corrosion cracking of armours due to CO<sub>2</sub> (rapid failure mode)
- Corrosion failures due to atmospheric backflow (air-breathing vents)
- Additional fatigue / corrosion-fatigue failures with new contributory factors
