OVERCOMING CHALLENGES: WORKING NEAR THE SEABED

SUBSEA EXPO '24

Viewpoint3 are providers of **3D Scanning** and **Dimensional Analysis** services, most commonly for the **Subsea** sector, and predominantly for the **Energy** industry.

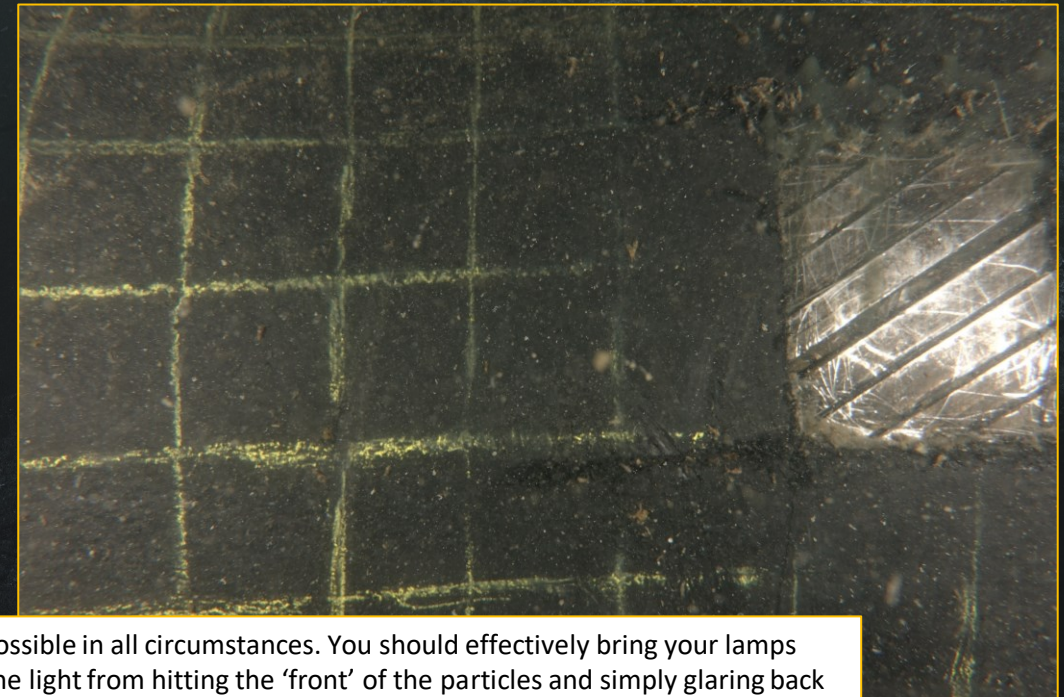
Unless it's proper 'pea-soup' conditions, there are ways of overcoming turbid conditions. The below images were collected by a diver in atrocious visibility conditions, but image collection was enabled using back-scatter reduction photography techniques and by scribbling with a crayon.

Speaker: Reducing back-scatter is one of the most common mitigations, but is not possible in all circumstances. You should effectively bring your lamps forward and point them toward the centre of the scene. This will prevent much of the light from hitting the 'front' of the particles and simply glaring back at the camera's lens, removing most of the value from your image. We also have to take the subject matter and distance to object into consideration. You'll notice that the image is at its brightest at the edges, and that much of the particles have been successfully by-passed.

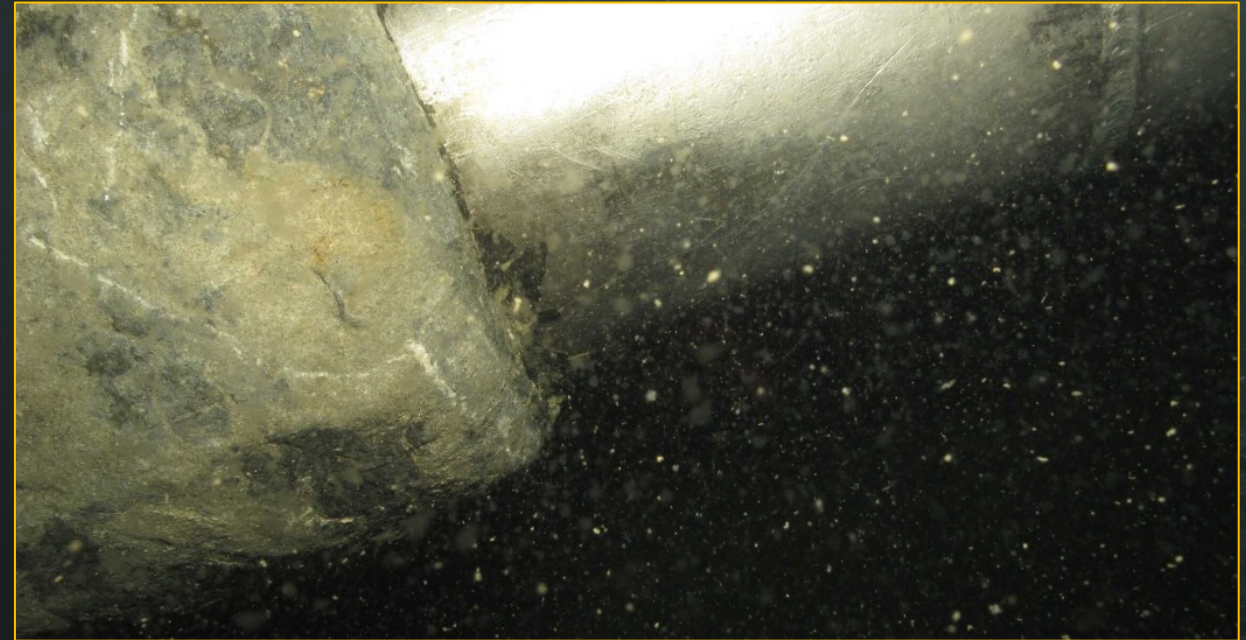
POST SEDIMENT SETTLING

As we can see, the visibility at the site improved over time, and the capture was generally completed within specified tidal timings.

Speaker: Whilst the visibility did gradually improve, it never got close to the stage of being ideal. We had advised the client of this challenge ahead of time so it didn't come as a surprise that the data collection was slower than usual.

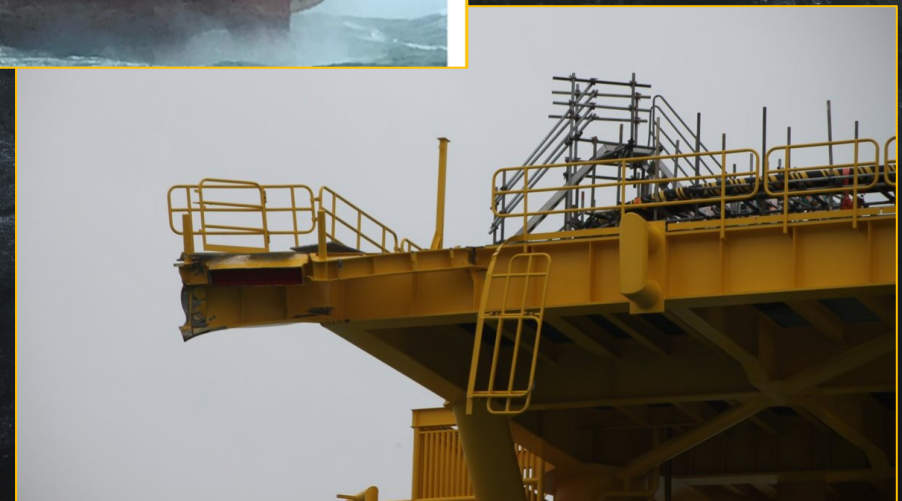
PLATFORM DAMAGE

As a result of a request from a marine insurance company, a prominent marine contractor from the Dutch sector approached us following a collision between a vessel and a wind-farm jacket.

With the lift-barge on hire to install sub-station, assessing damage to the leg was critically urgent.

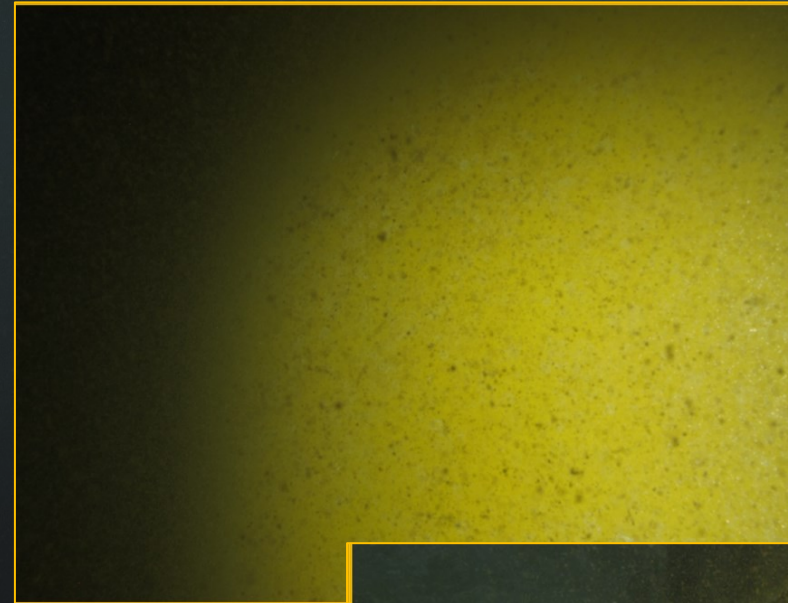
POOR
VISIBILITY

As many of you will know, visibility in the Dutch sector can be atrocious, with currents and tides picking up seabed sediment on an almost constant basis.

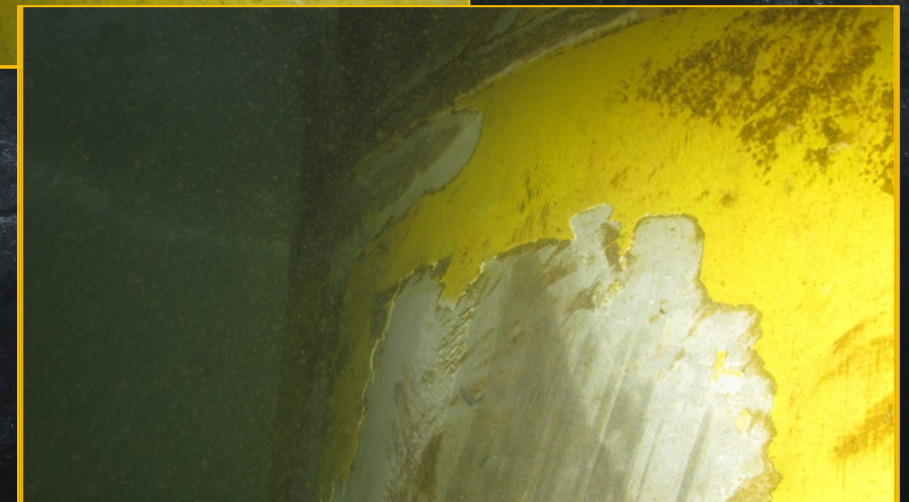
IMAGE OF OPPORTUNITY

The Viewport3 team were very quickly reduced to taking 'images of opportunity' as we waited for ROV positioning and decent visibility to be aligned by the Gods of subsea inspection.

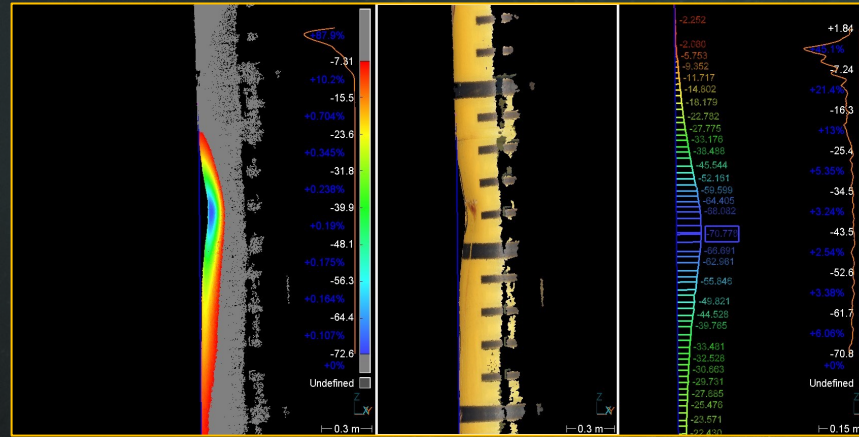
3D ANALYSIS RESULTS

One of the inherent benefits of photogrammetry is that we can model objects that cannot be viewed in a single image.

Whilst we can have 80% of pixels that are of no use, the process will use the valuable 20% from as many images as it has access to, and hence the 3D information is gradually built up.

Speaker: This included collecting topside images from the vessel using a high-end DSLR camera, and by straddling the tide, creating a 3D dataset which reached from 2 or 3 metres underwater, up to around 15 metres above. As photogrammetry uses many images to create a dataset, we did in the end collect enough information to make an uncompromised 3D dataset, despite some images containing only a fraction of valuable data.

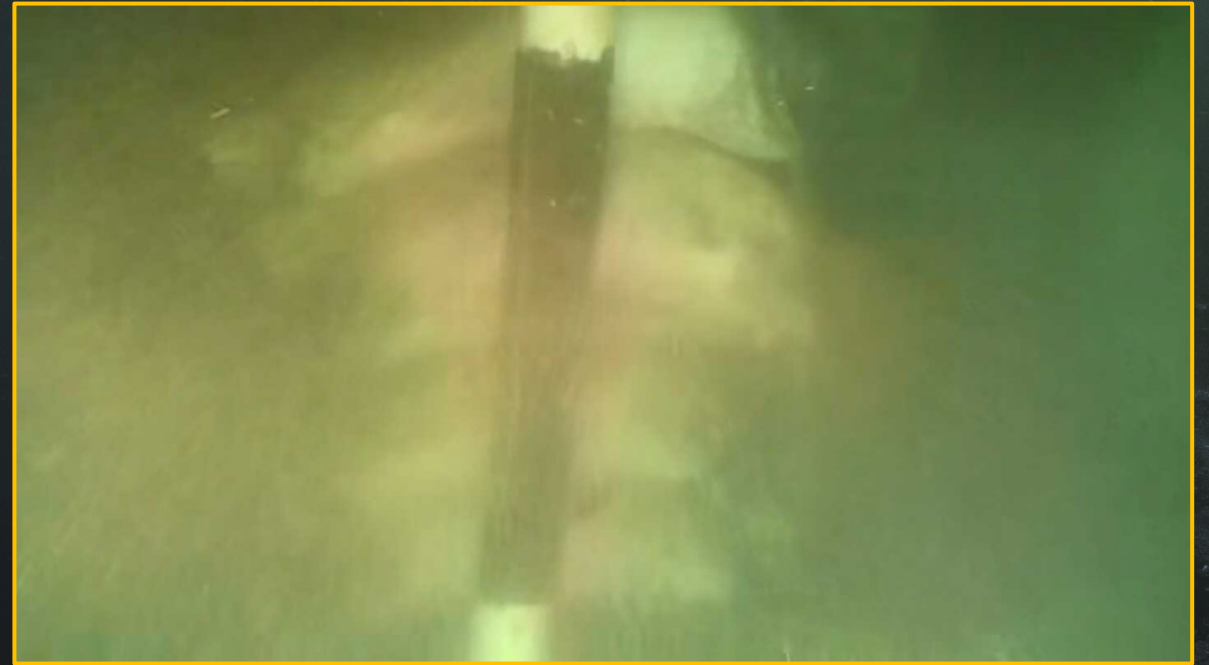
CLIENT PROVIDED VIDEO DATA

We were tasked by a returning customer with analysing data collected by an ROVs flight-camera, pertaining to a damaged methanol spool.

Speaker: In an emergency situation, we were tasked by one of our partners with providing a 3D version of a leaking methanol line. In case you can't tell, this image shows a meth line, some grout bags, and some pink tell-tale dye added by the platform.

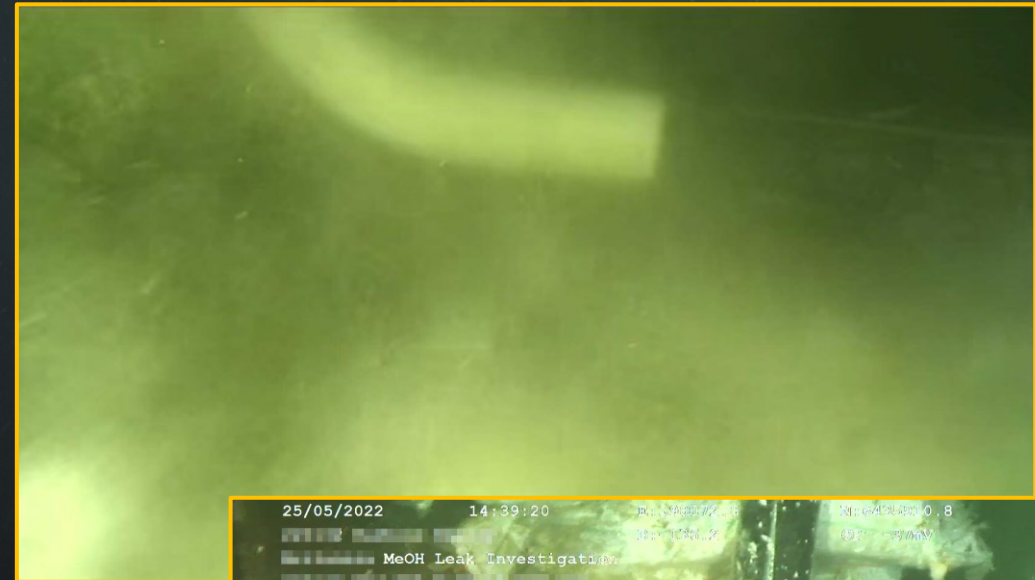
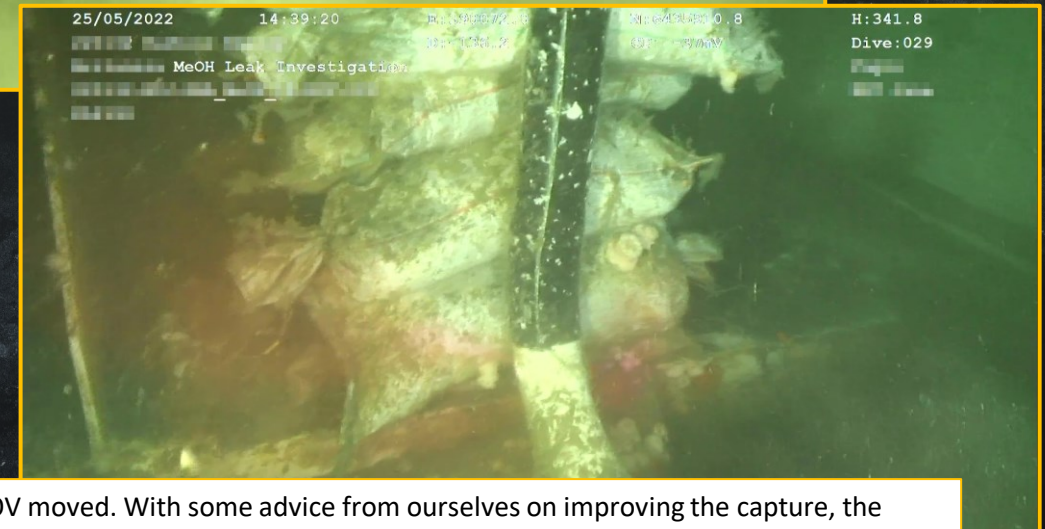
CLIENT
PROVIDED
VIDEO
DATA

With a repair clamp design in-hand, the client sought only to confirm the diameter of the line and the 'actual' angle of the bend.

The footage however, ranged from terrible, all the way to mediocre because the light, silty seabed kicked-up every time the ROV moved or dared to use its thrusters.

Speaker: The seabed in this area was as light and silty as we've seen, and kicked up every time the ROV moved. With some advice from ourselves on improving the capture, the client's ROV team were able to collect better data 2nd time around. Showing the true-flexibility of photogrammetry, this project was completed without the vessel returning to port to collect people or equipment. We simply instructed them in techniques that would maximise the capability of the ROVs flight camera and completed the work with what was available onboard at the time.

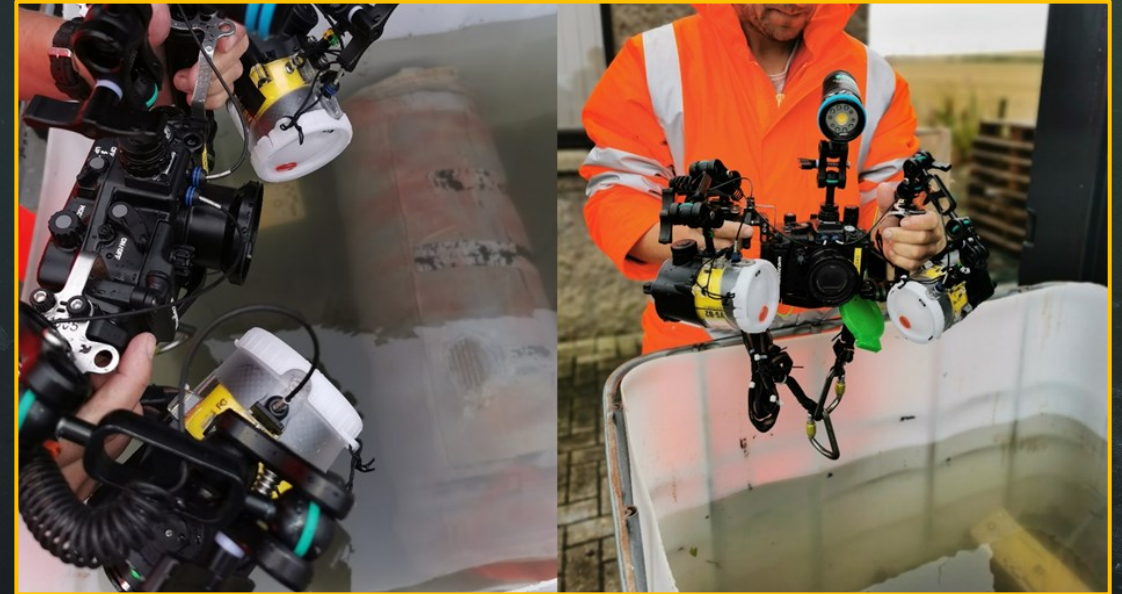
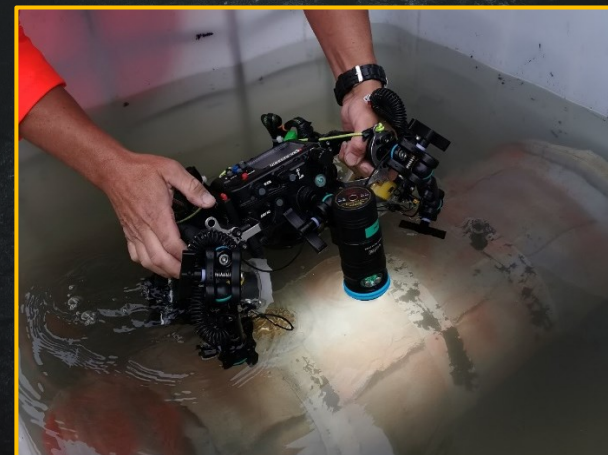
DIVER TRAINING

Touching briefly on this task, we trained a Bluestream diver at our Aberdeen HQ for this task in the Dutch sector.

Speaker: When it comes to efficiency of capture in turbid conditions, there is no substitute for a well-trained diver, who can adjust camera settings and most importantly lighting angles to overcome challenging conditions. This fine gentleman came to us from Holland for a couple of days training and was taught the correct techniques in our state-of-the-art butchered IBC that we'd chucked some dirt into.

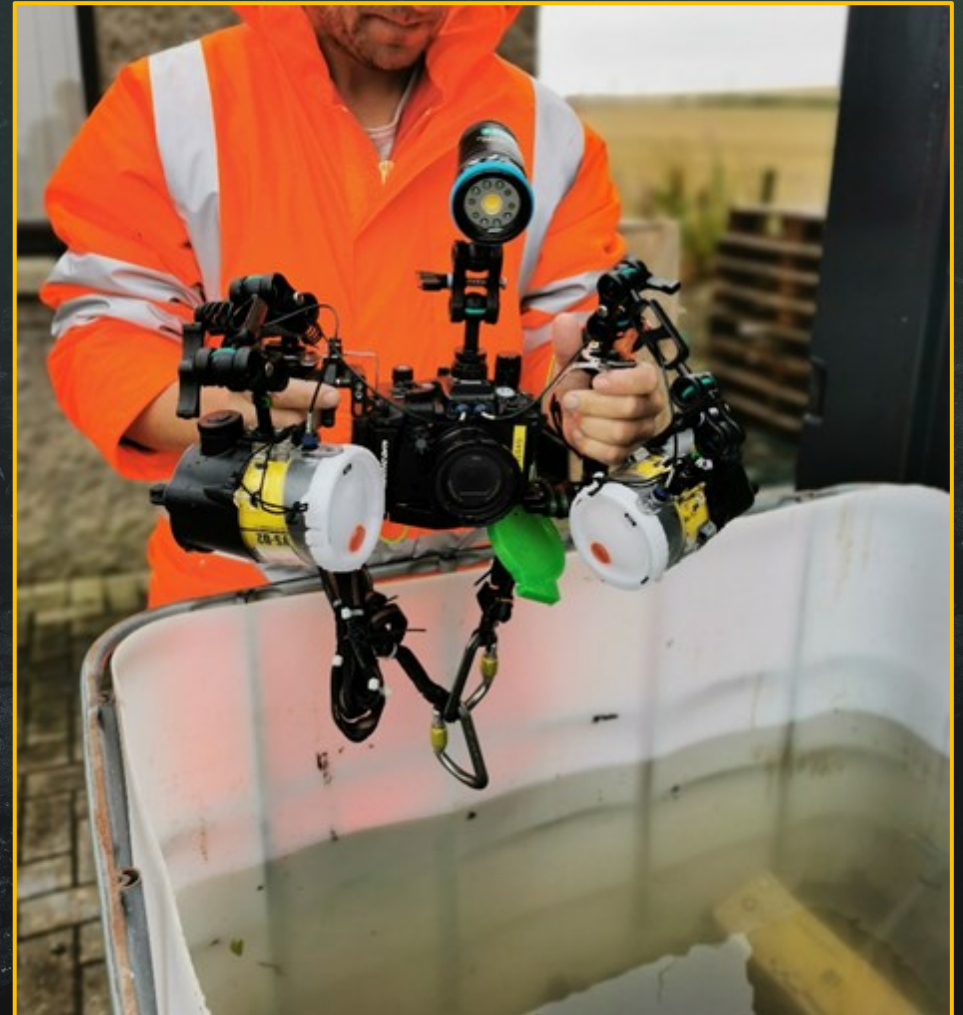
DIVER COLLECTED IMAGES

Divers have an ability to alter their capture techniques in ways that are difficult to replicate by ROV, due to the diver's ability to alter the position of the light-source 'on-the-fly'.

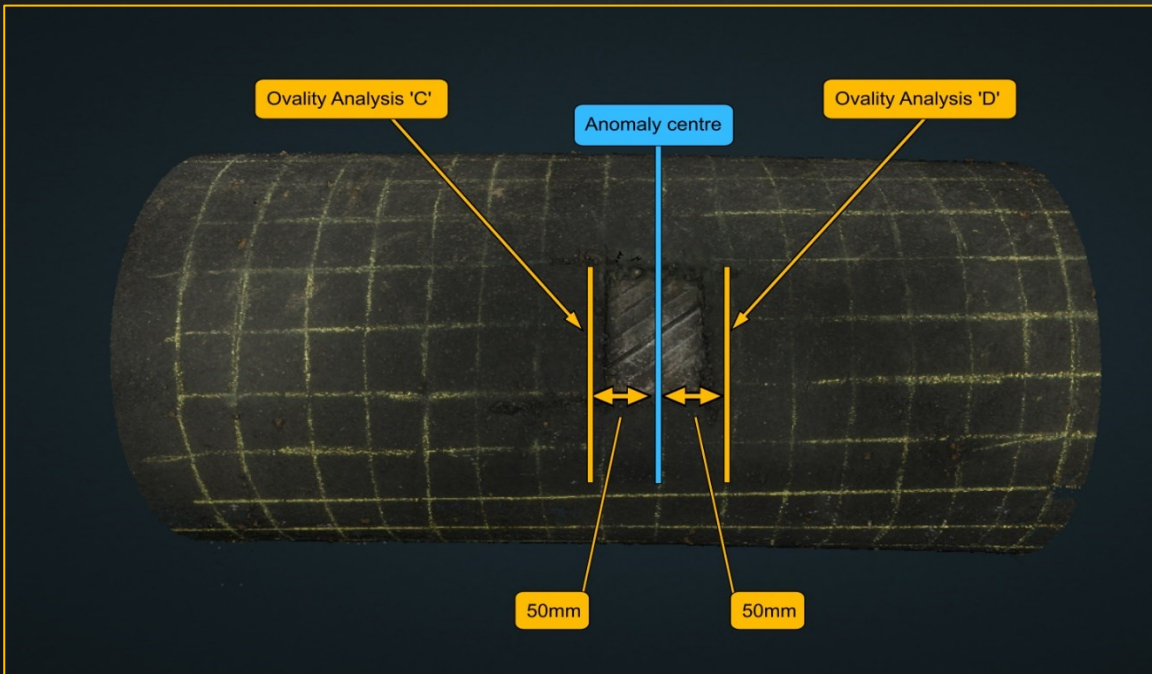
ANALYSIS RESULTS

Speaker: So once again, we have the data requested by the client despite the conditions. The application of crayon scribbles also helped the efficiency of the 3D reconstruction process.
